# HOME REPORT

29 THE AULD ROAD  
VILLAGE  
GLASGOW  
G67 2RF

# Energy Performance Certificate (EPC)

29 THE AULD ROAD, VILLAGE, GLASGOW, G67 2RF

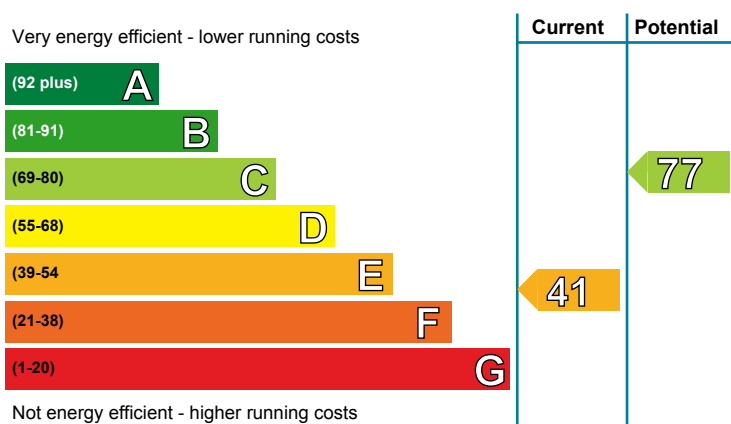
## Energy Efficiency Rating

This graph shows the current efficiency of your home, taking into account both energy efficiency and fuel costs. The higher this rating, the lower your fuel bills are likely to be.

Your current rating is **band E (41)**. The average rating for EPCs in Scotland is **band D (61)**.

The potential rating shows the effect of undertaking all of the improvement measures listed within your recommendations report.

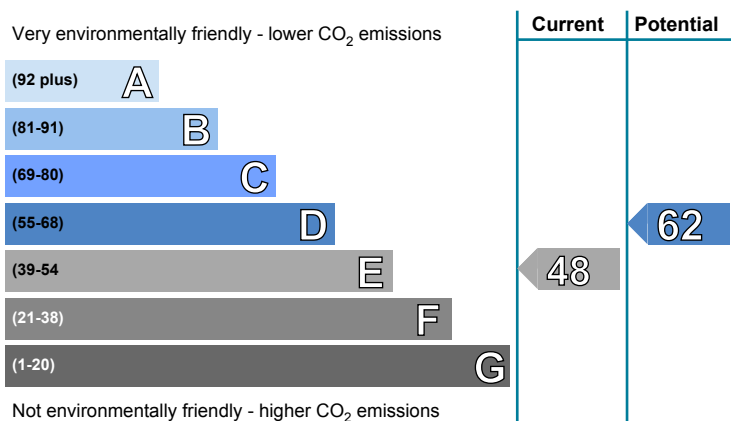
## Environmental Impact (CO<sub>2</sub>) Rating

This graph shows the effect of your home on the environment in terms of carbon dioxide (CO<sub>2</sub>) emissions. The higher the rating, the less impact it has on the environment.

Your current rating is **band E (48)**. The average rating for EPCs in Scotland is **band D (59)**.

The potential rating shows the effect of undertaking all of the improvement measures listed within your recommendations report.
